Manhole Inspection Summary

Manhole # S25YY_G01MH

Record Plat: **25YY** Node: **G01** Status: **New Manhole (Not in GIS)** Insp Date: **6/13/07 12:00 AM**

Location Address: **3300 CIPPER RD** Cross Street: **CLIPPER MILL RD**

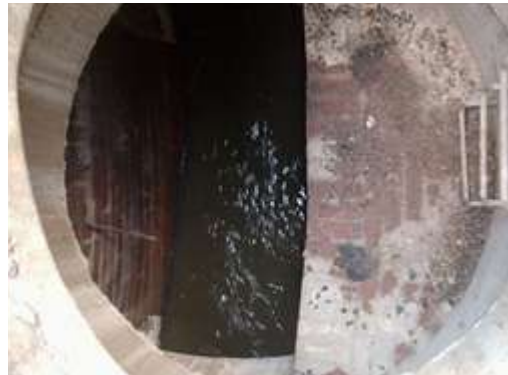
Top View

Bench debris.

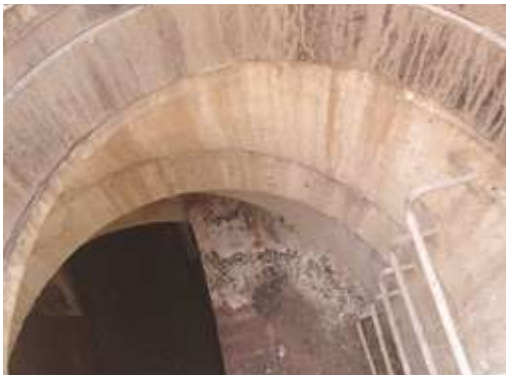
Defect

Frame leaks. Adjustment and Corbel infiltration - other side.

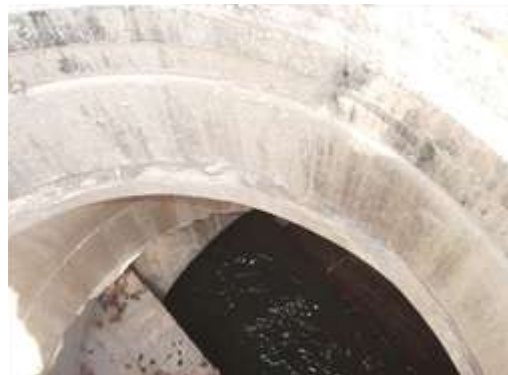
Defect

Frame leaks. Adjustment and Corbel infiltration.

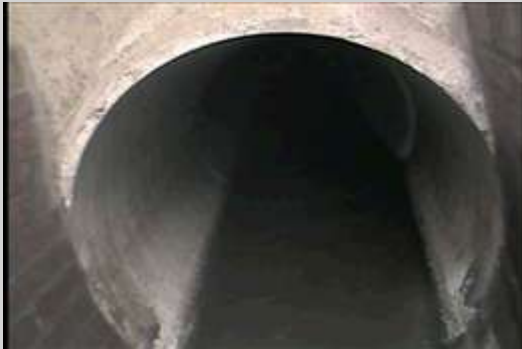
36 in. Circular Gravity Sewer Pipe Out @ 12 O'Clock

Pipe Material: **Unknown** ☐ Pipe Lined

Invert Depth: **9.80** (ft.) Flow Characteristics: **Fast**

Deposits: ☒ None ☐ Mud ☐ Sludge ☐ Debris ☐ Grease

Infiltration: **None** Pipe Seal Cond: **Unknown**

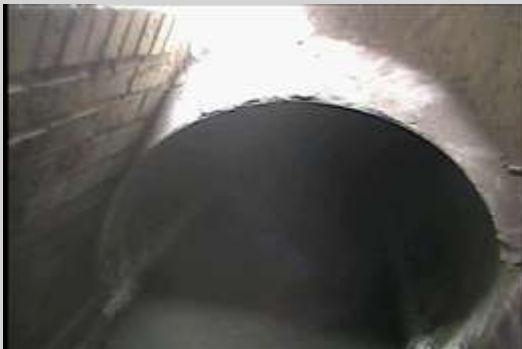
36 in. Circular Gravity Sewer Pipe In @ 7 O'Clock

Pipe Material: **Unknown** ☐ Pipe Lined

Invert Depth: **9.70** (ft.) Flow Characteristics: **Fast**

Deposits: ☒ None ☐ Mud ☐ Sludge ☐ Debris ☐ Grease

Infiltration: **None** Pipe Seal Cond: **Unknown**
